MANDATORY BULLETIN č. 2008-001 A

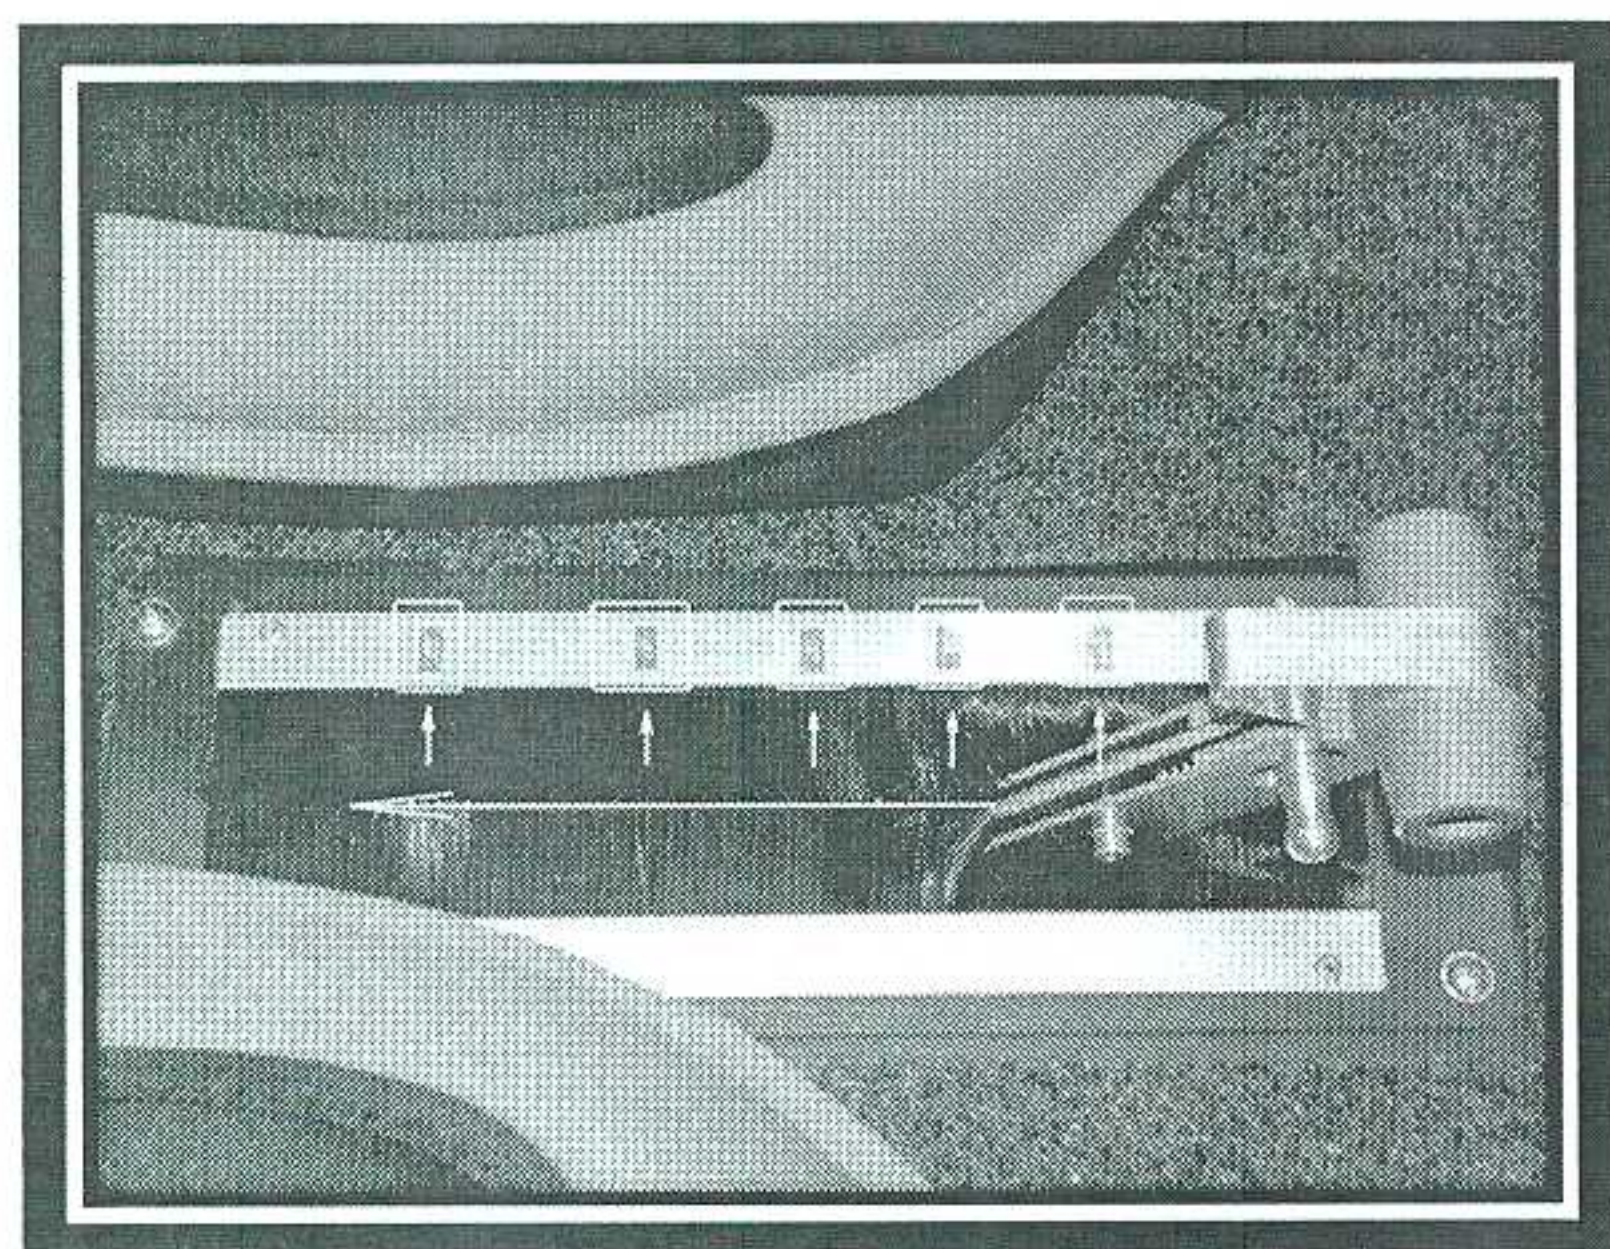
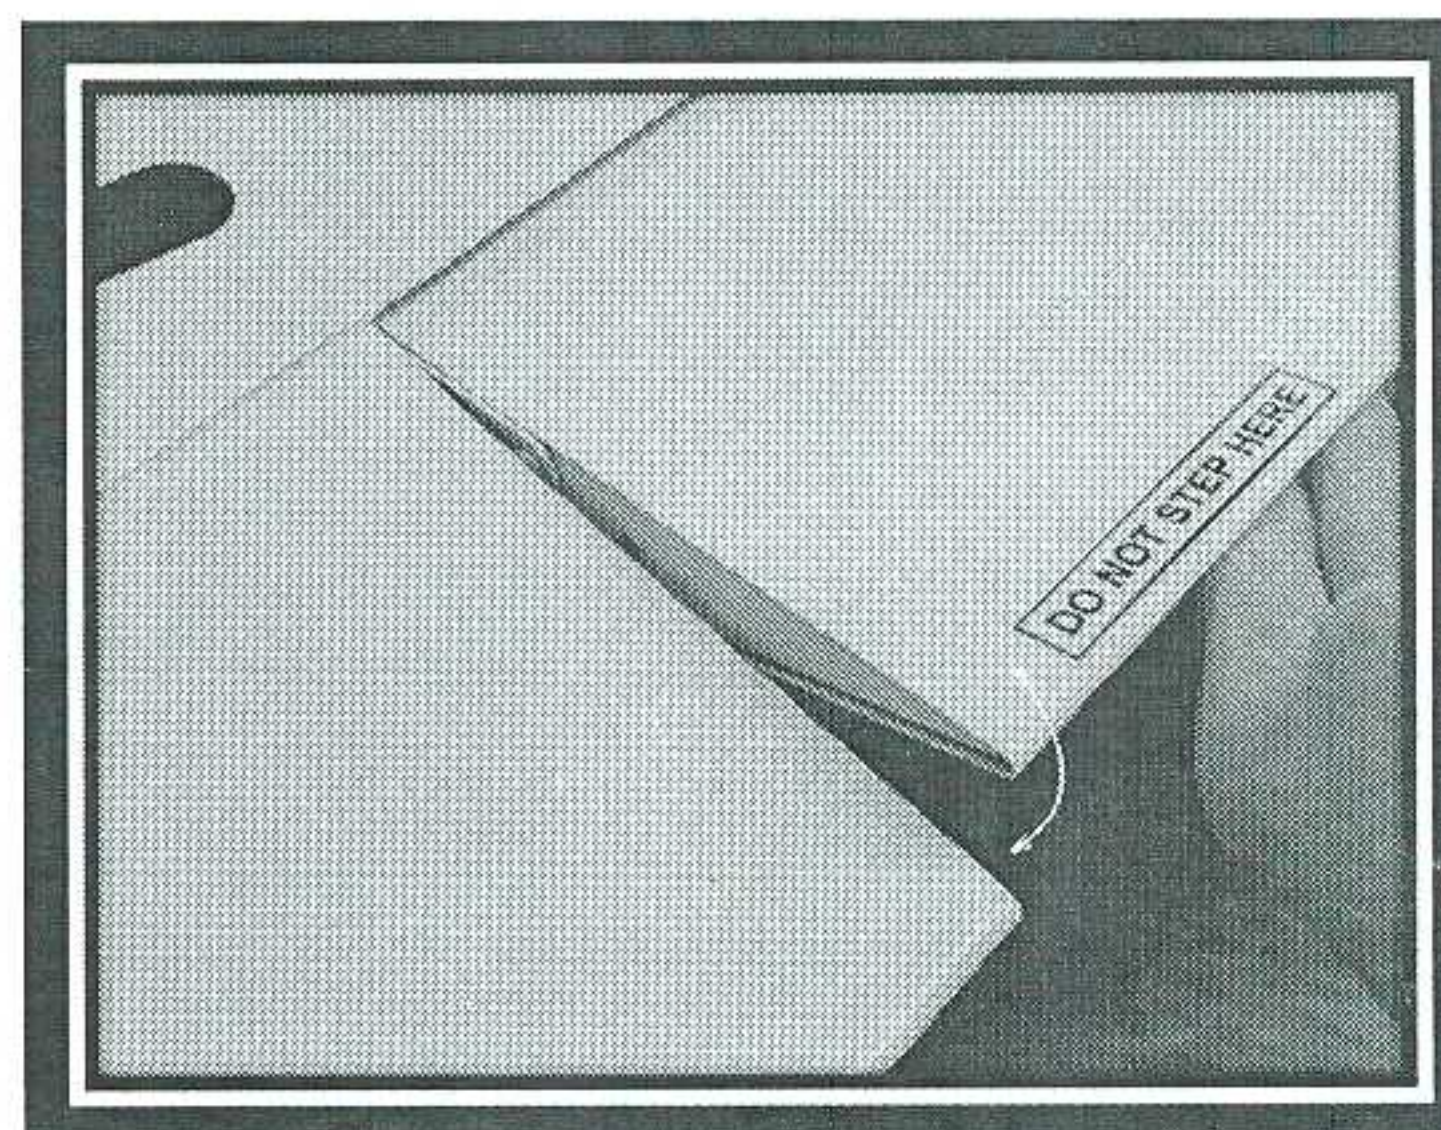
- 1. RELATE TO:** All aircraft and kits DV 1 SKYLARK
- 2. REASON :** The accident of airplane 6/7/2008 DV 1 – SKYLARK airport Zábřeh
- 3. ACTION :** Check will flap, flange thickness.
Pending the implementation of the prohibition of operation. The owner of the aircraft shall acquaint all users of its aircraft with this measure.
- 4. TERM OF ACTION :** Without delay, the measurement results to the manufacturer.
- 5. CARRIED :** The manufacturer or the manufacturer responsible for service company.
- 6. REQUIRED PARTS :** Gives manufacturer
- 7. PROCESS :** Check flap free move in each position

The aircraft owner must submit a report to the manufacturer after inspection and measurement. When thickness of 1,5mm and more, without defects and deformations of aircraft can operate without restriction. If defects and the thickness of less than 1,5mm are detected, is necessary to replace the part. The owner of aircraft will responsibility for exchange before the next operation of the aircraft

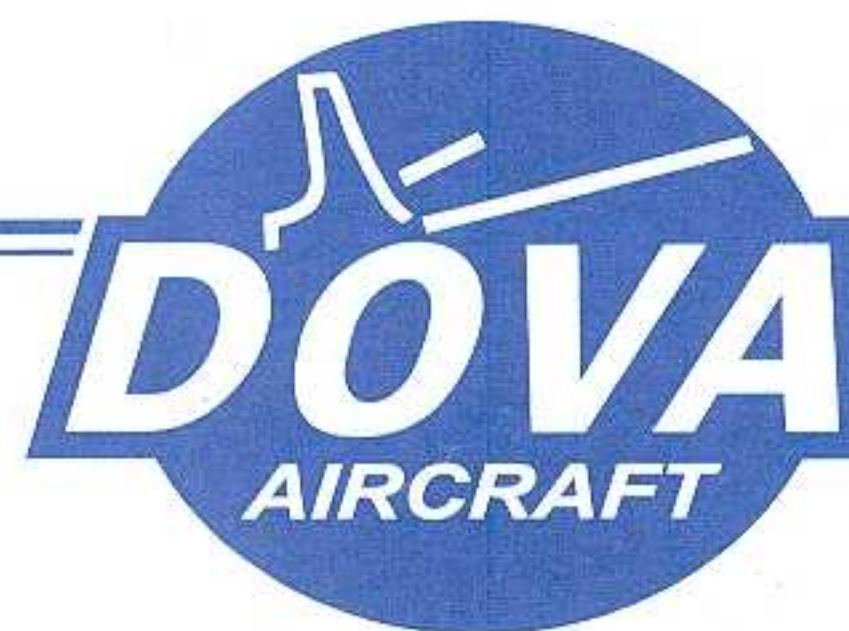
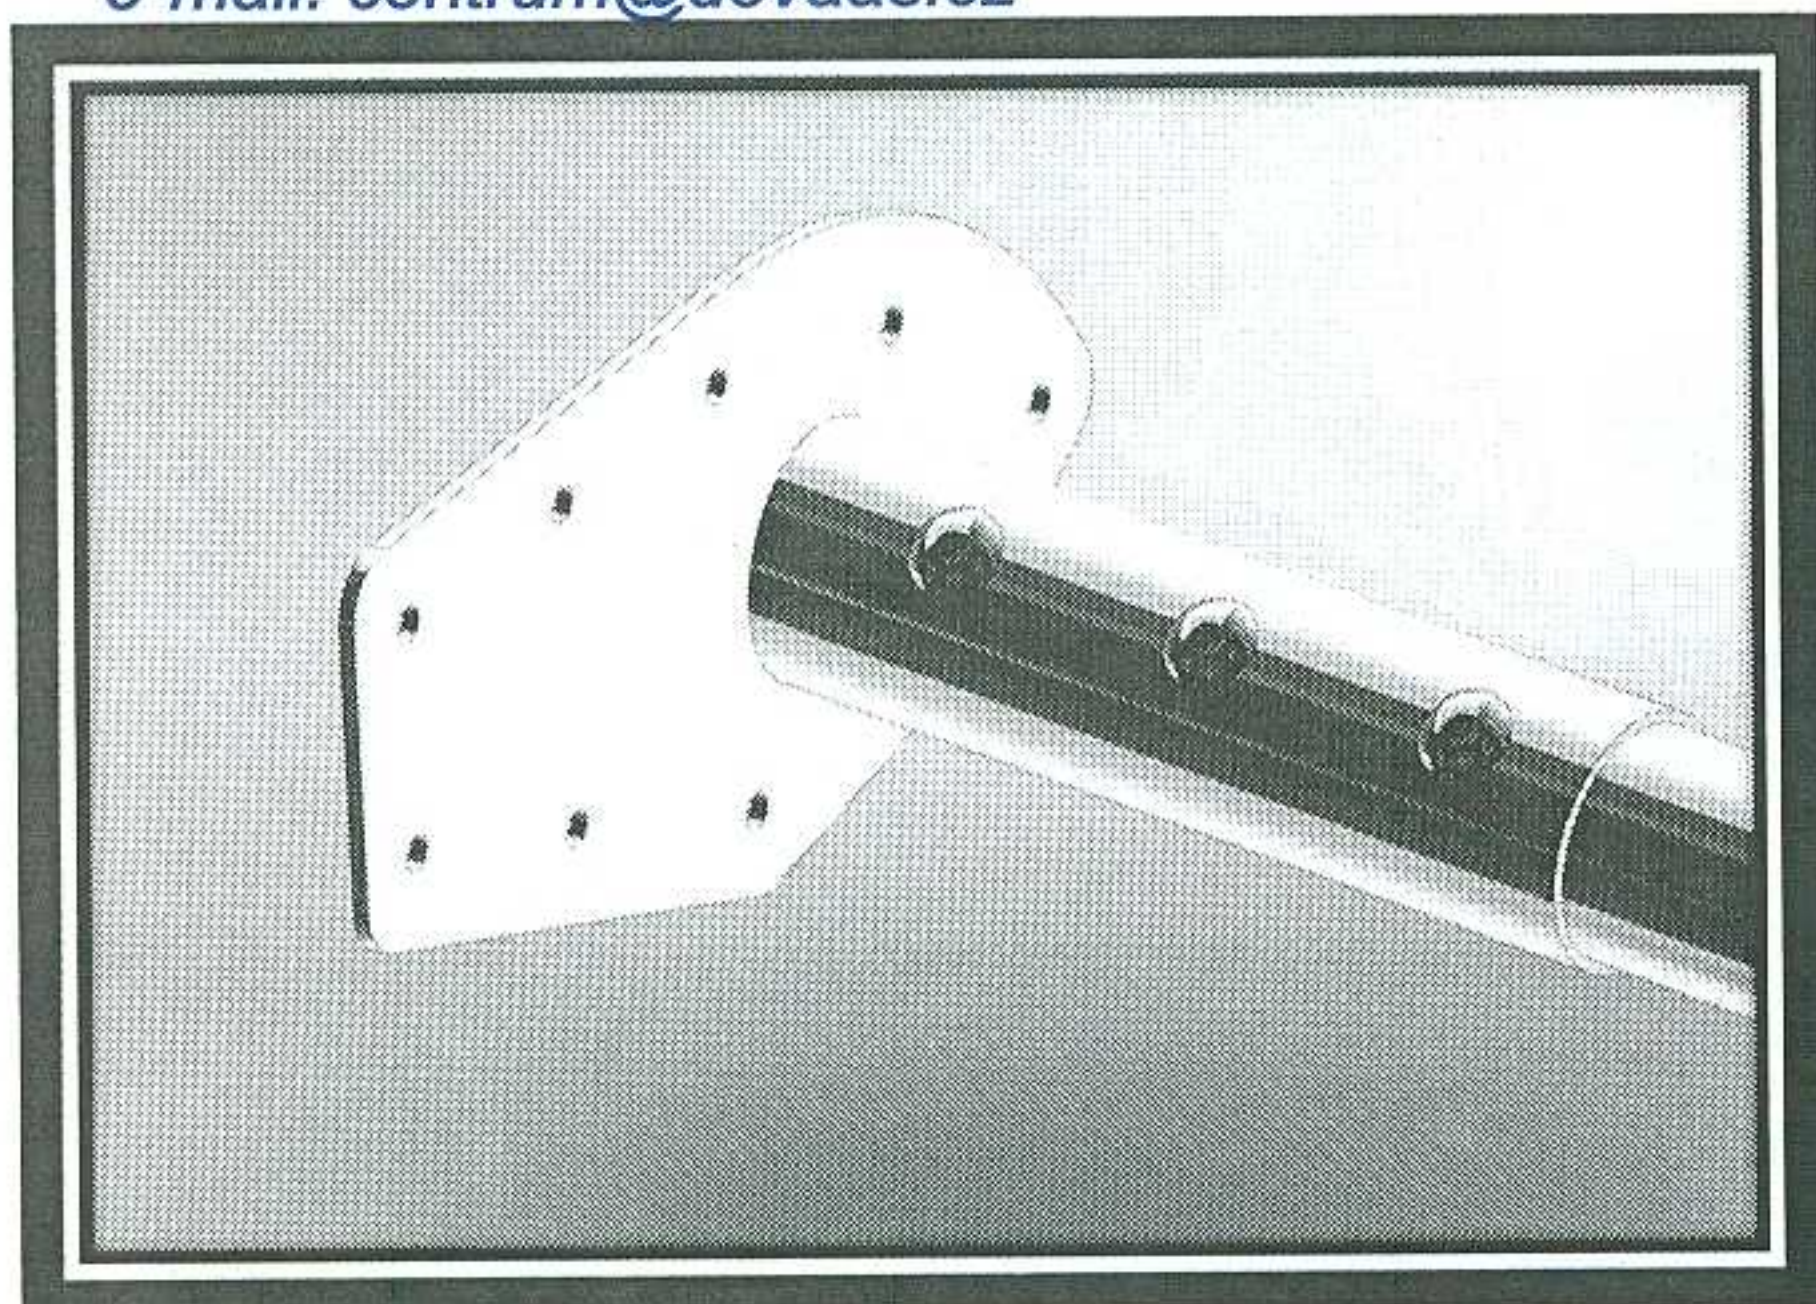
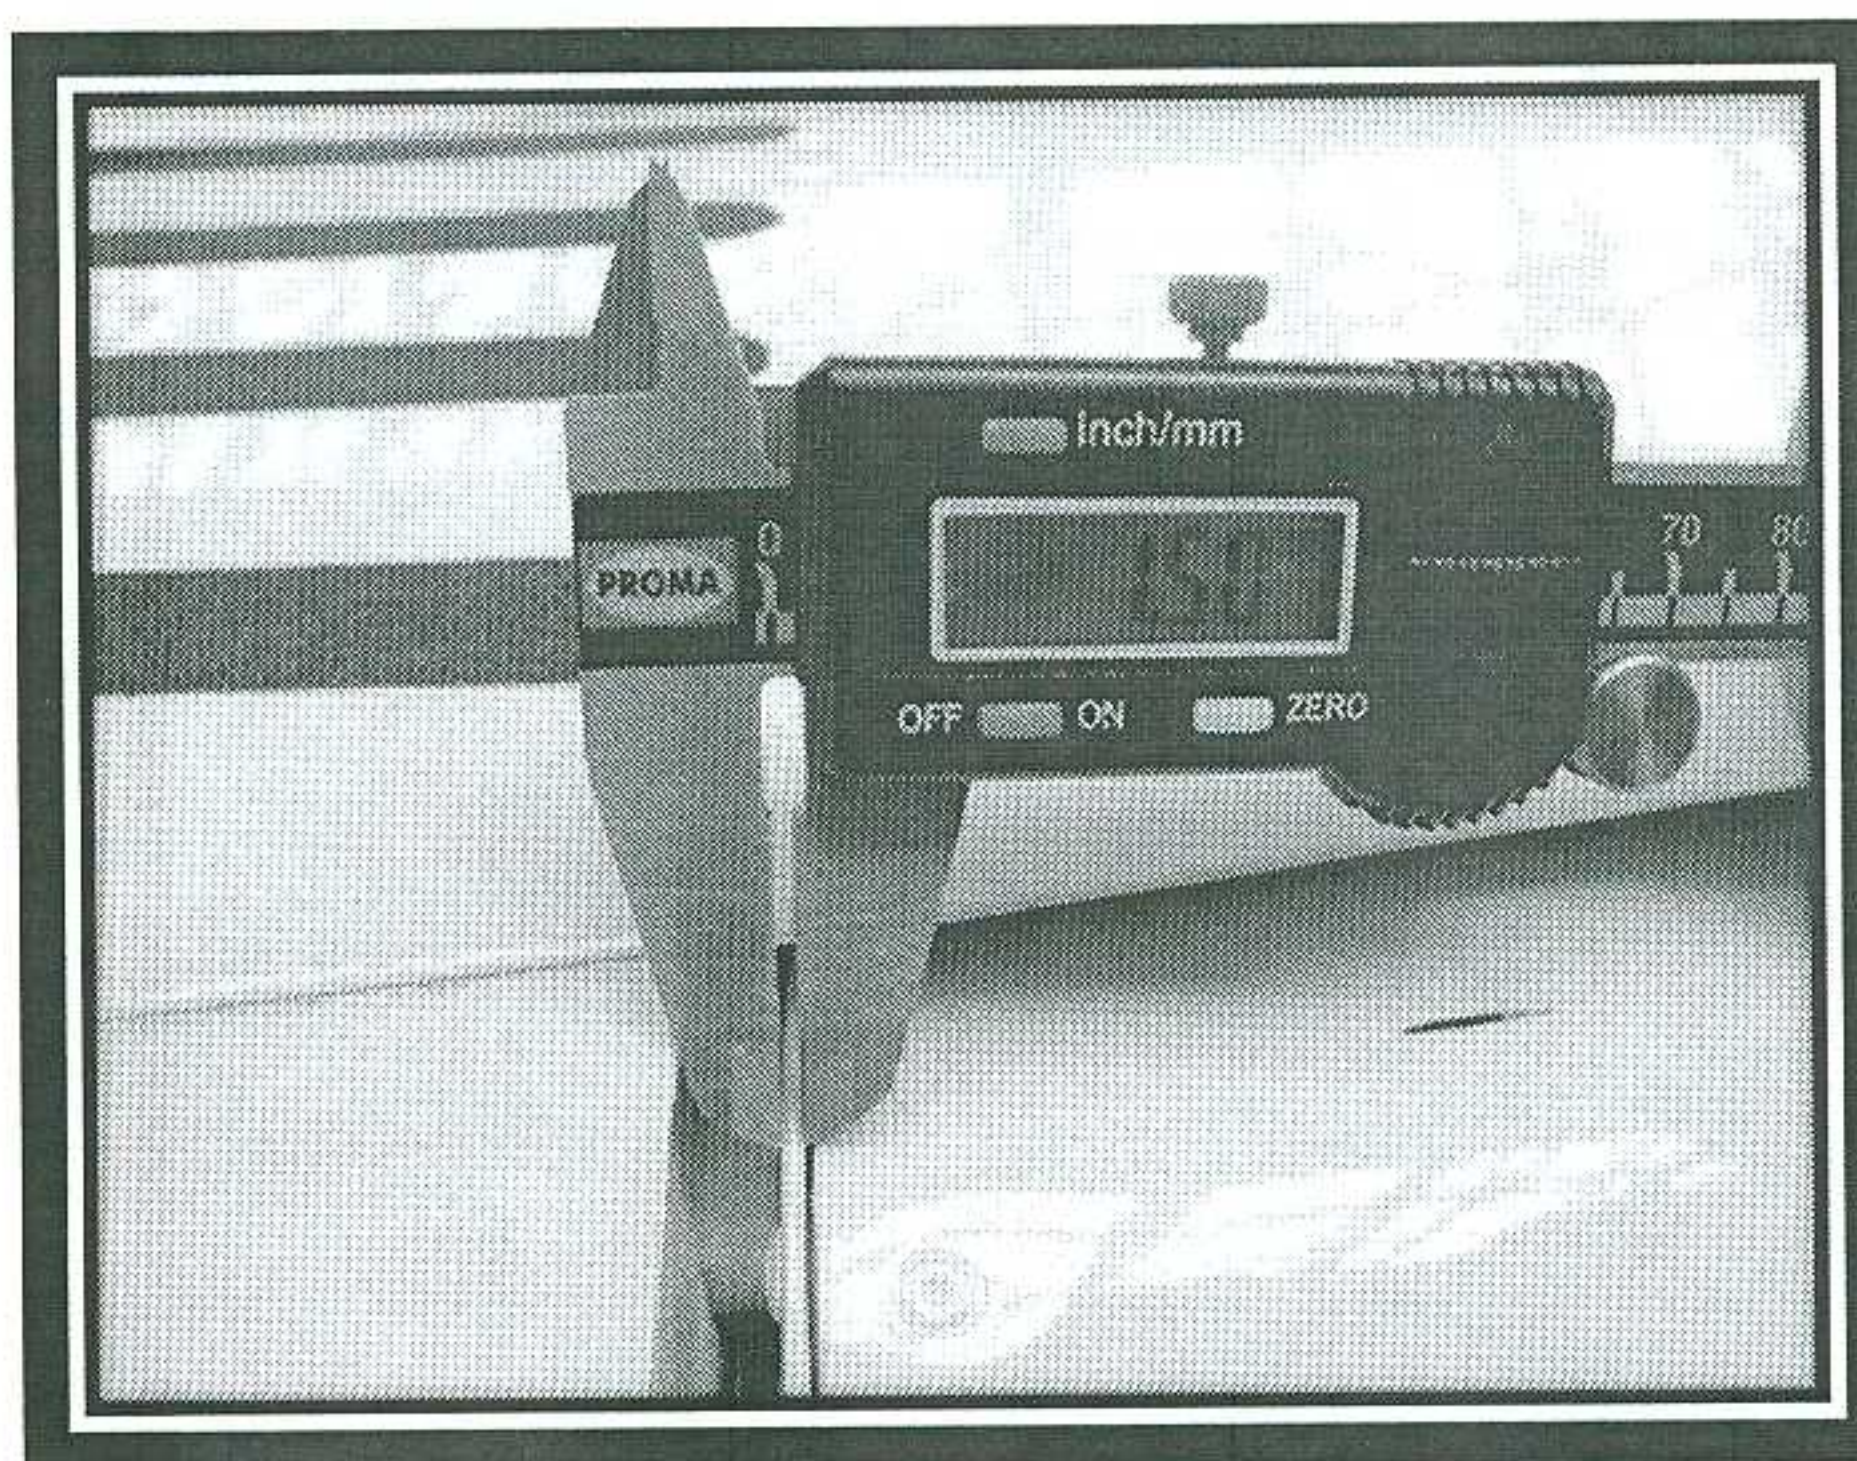
Check the thickness of flange

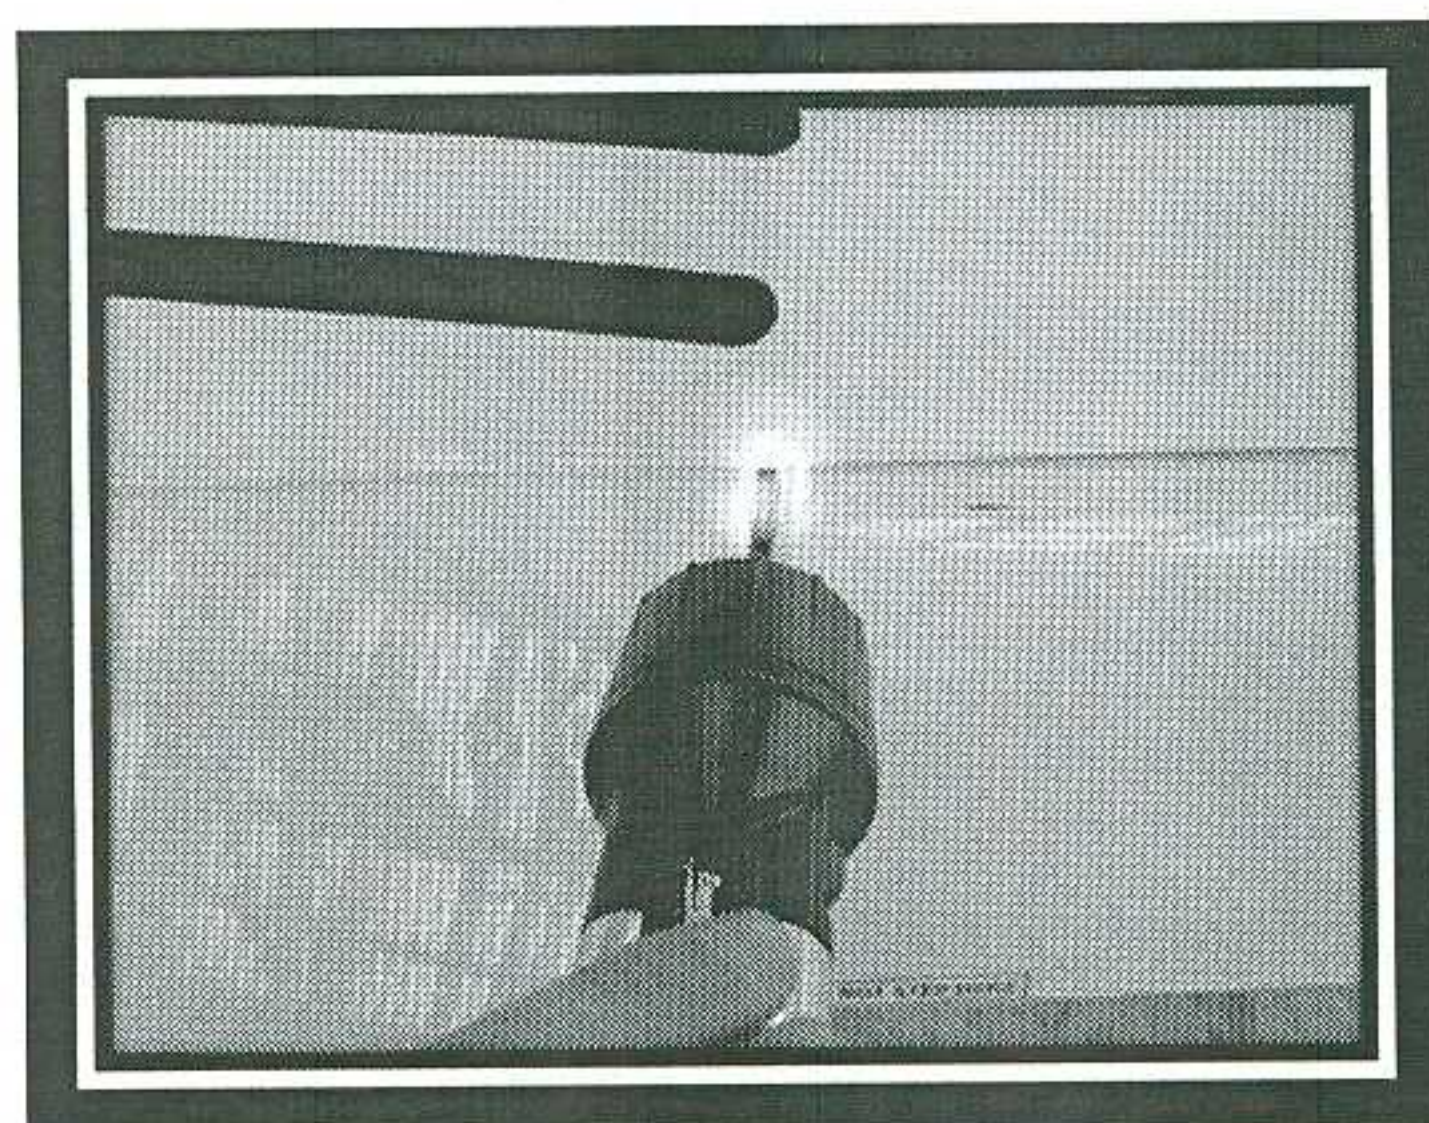
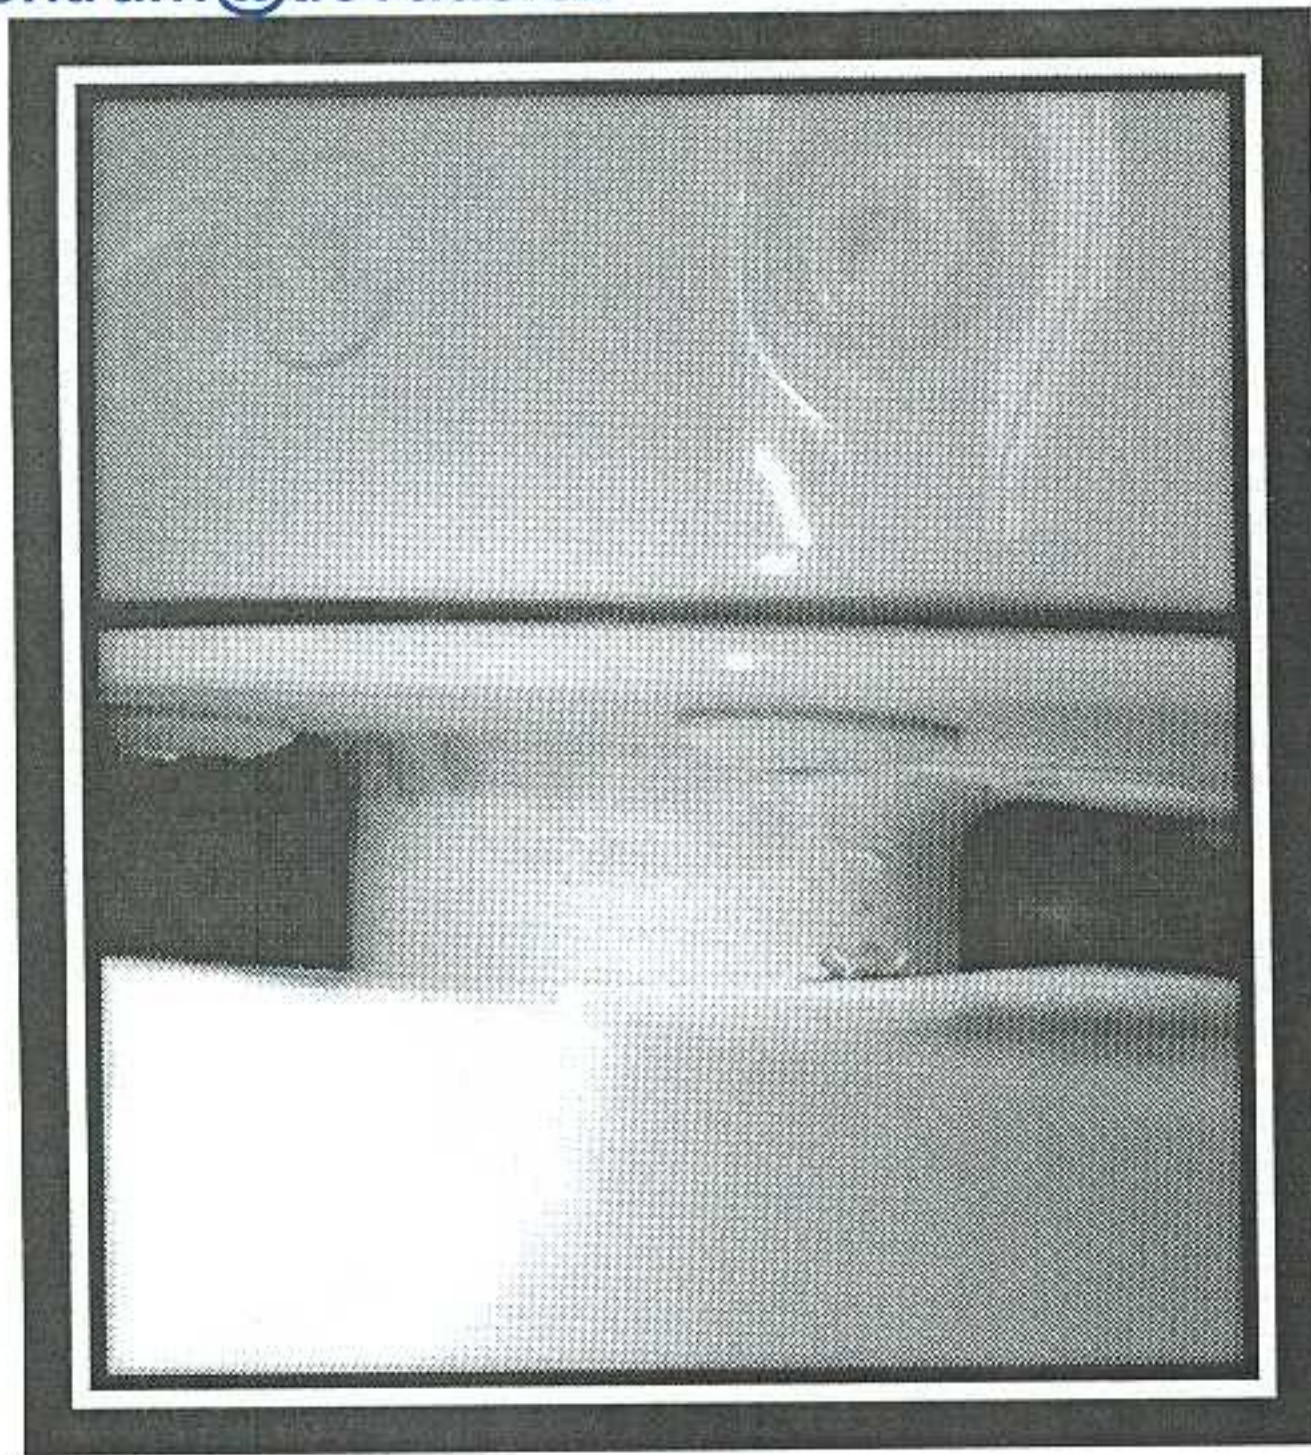
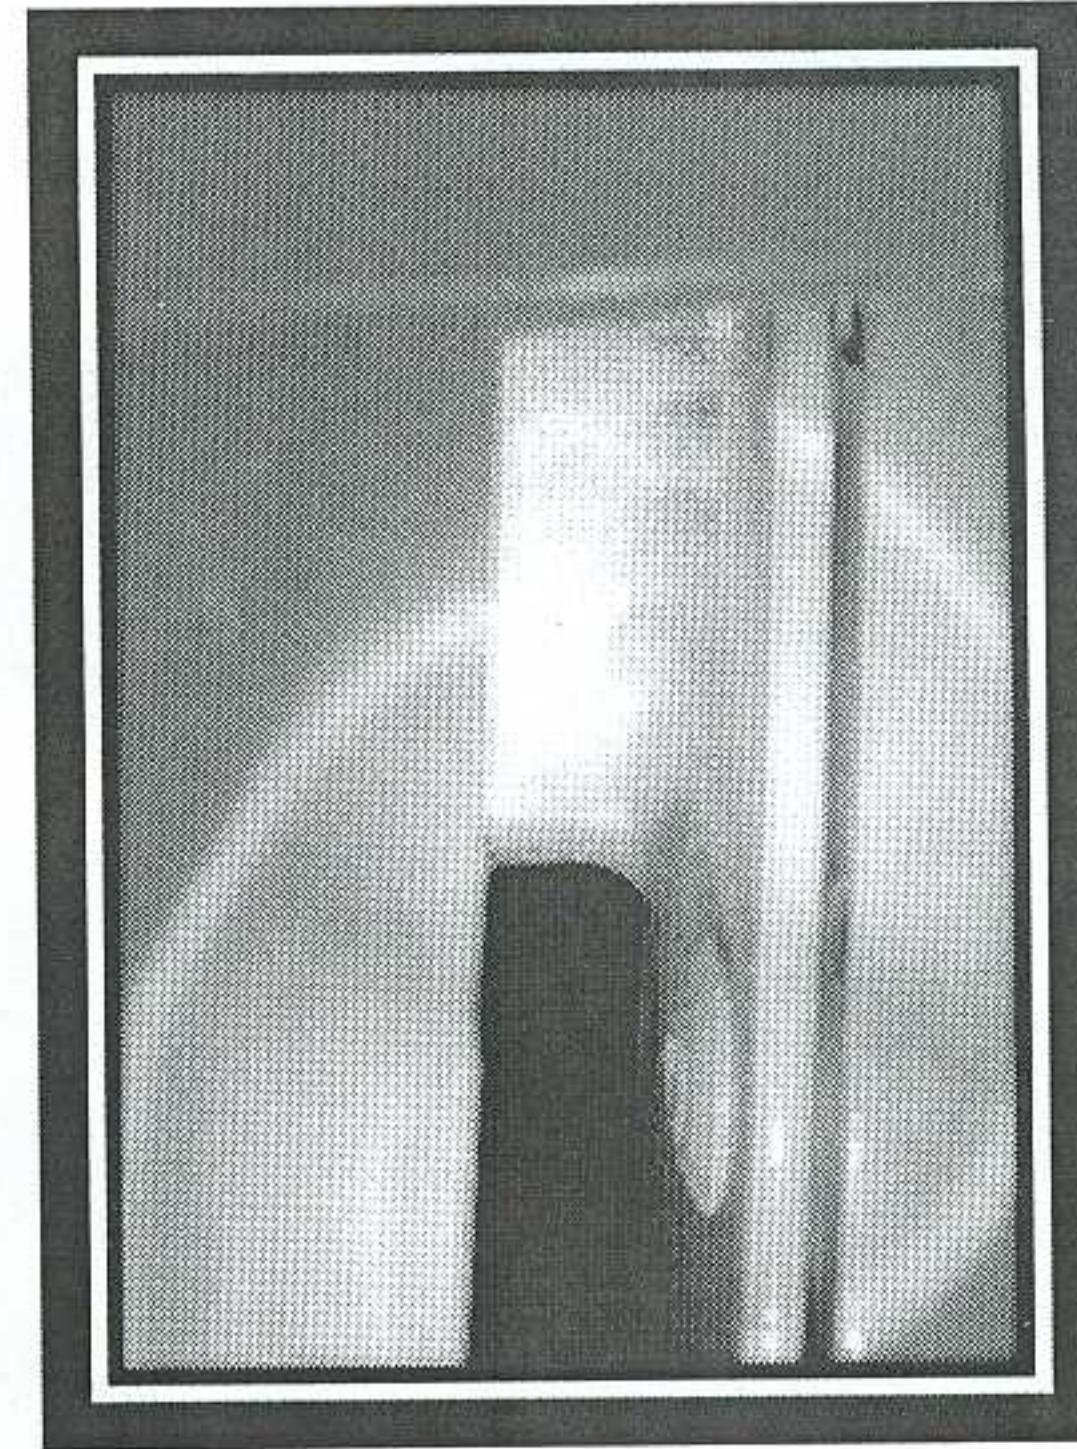
Monitoring of others defects or deformations
